CARDIVNSWC-TR-61-99-18 September 1999

Survivability, Structures, and Materials Directorate
Technical Report

**ADVANCED MEASURES TO CONTROL GALVANIC
CORROSION IN PIPING SYSTEMS**

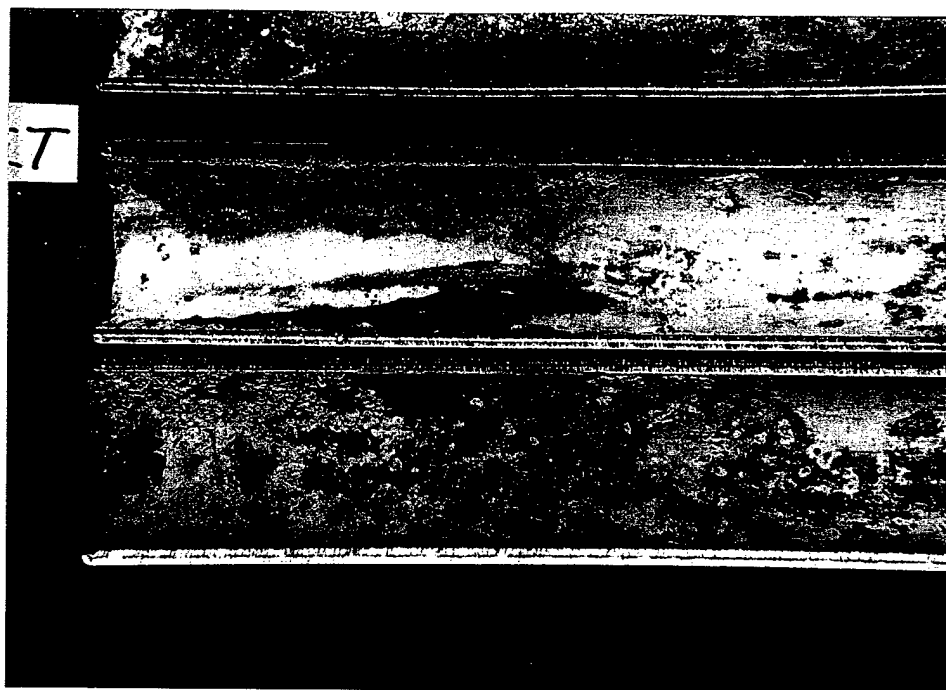
Figure 34 - Top and bottom sections of copper-nickel pipe section coupled to Alloy 625 (loop 12). Inlet (left side) is at junction with the cathodic 625 section. Heavy copper deposits on copper alloy surfaces, particularly along the bottom of pipe (lower tube half).
